**CEMENTAID**

# Prevention of Corrosion

Protecting reinforced concrete from acid attack

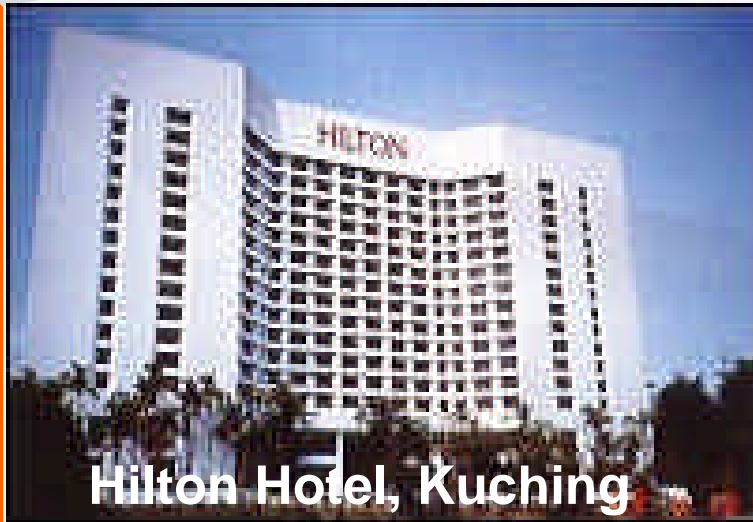
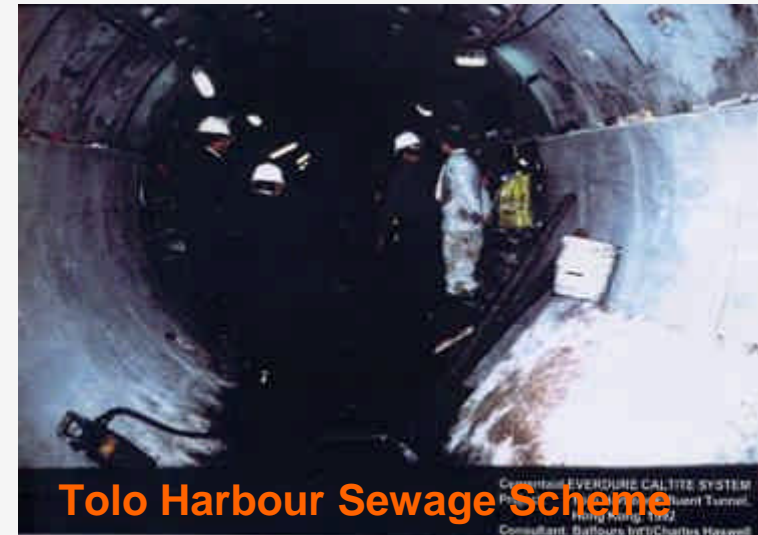
## Maintenance-Free Concrete for Acid / Sulphate Environments

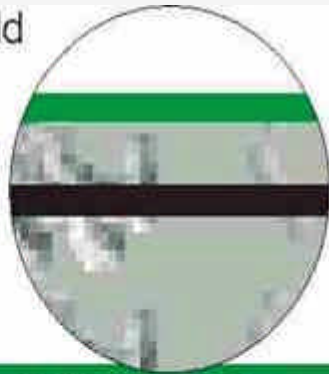
Cementaid SuperShield  
Low Build Epoxy

Non-Absorptive  
Caltite Concrete

Mechanical Damage to Low Build Epoxy

Water borne acids are NOT absorbed by Caltite concrete. Only the extreme, DIAMITE hardened surface of the Caltite concrete is exposed to corrosion.

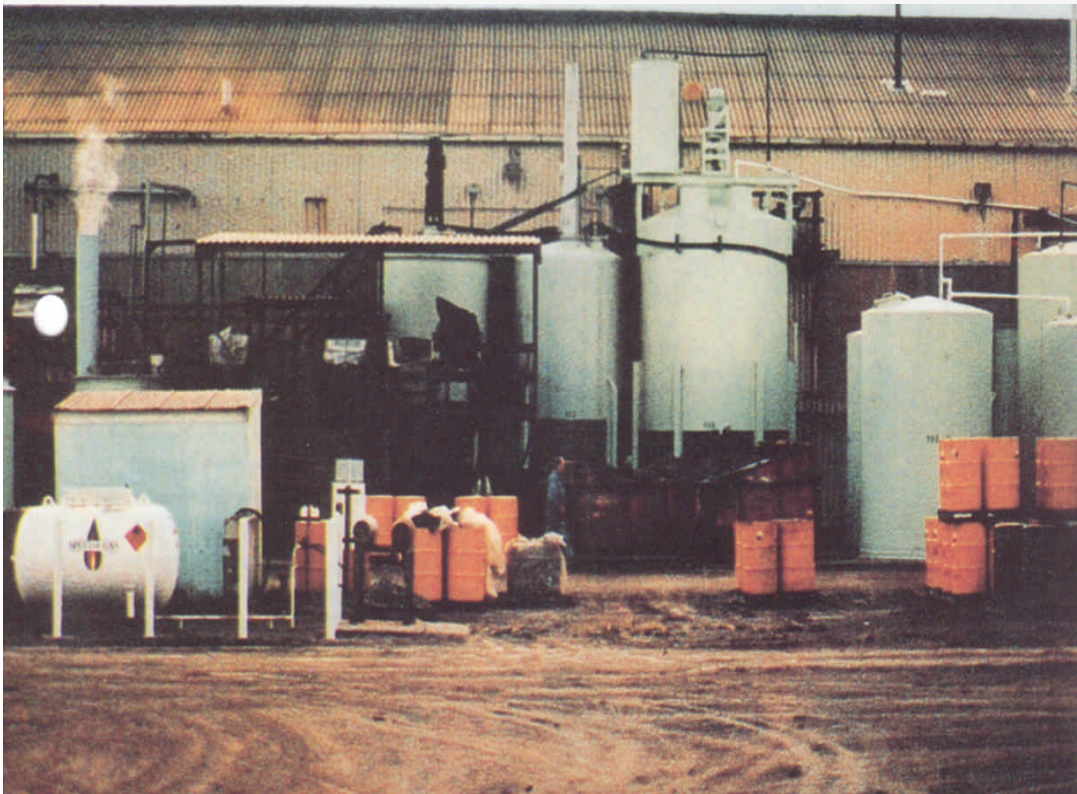
# Hardman Chemicals, NSW Australia

*Daily exposure to 32% Hydrochloric Acid, and Zinc Chloride solutions*

- **Pre-1970:** Initial 6 inch (150mm) thick **plain concrete** slab reduced to "rubble" after approx. 6 months.
- **Deterioration rate** average **1" per month**
- Replacement slab plus epoxy coating **un-useable** after approx. 9 months

- **1970:** New Everdure Caltite System slab was cast (6" / 150mm thick)
- No Epoxy coating used **initially**
- After 18 months, the Caltite surface had been gradually eroded to a depth of ~1" (25mm) by constant acid "etching"
- **Deterioration rate 1" per 18 months**
- **18 fold improvement over plain slab**
- Test cores showed slab remained structurally sound @ over 6,000 psi
- **1972:** Etched surface washed with caustic, and reinstated in with bonded Caltite screed (25mm 1:3 sand:cement)
- A 1mm epoxy coating applied to protect the extreme surface of the Caltite topping against acid-etching.

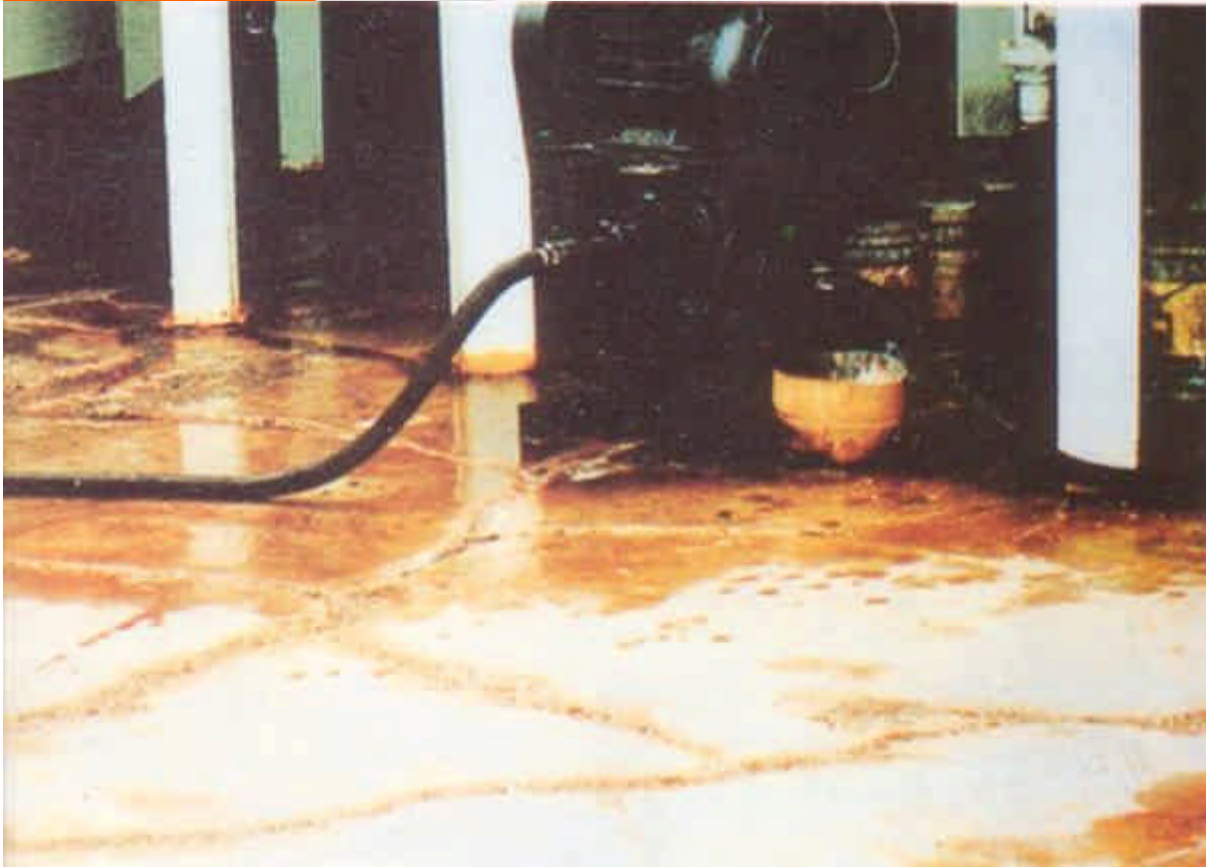
# Hardman Chemicals, NSW Australia

*Daily exposure to 32% Hydrochloric Acid, and Zinc Chloride solutions*

- Coating not able to bridge early-age micro-cracks in unreinforced Caltite topping
- *Hydrophobic Matrix* - Acids only able to access or contact extreme outer surface of the exposed crack “walls”
- CALTITE / Epoxy composite slab subject to acids, abrasion & impacts from wheeled & forklift traffic
- Photo after 20 years exposure
- 26 X extended service life compared to plain concrete slab plus epoxy coating  
(240 months / 20 years vs. 9 months)

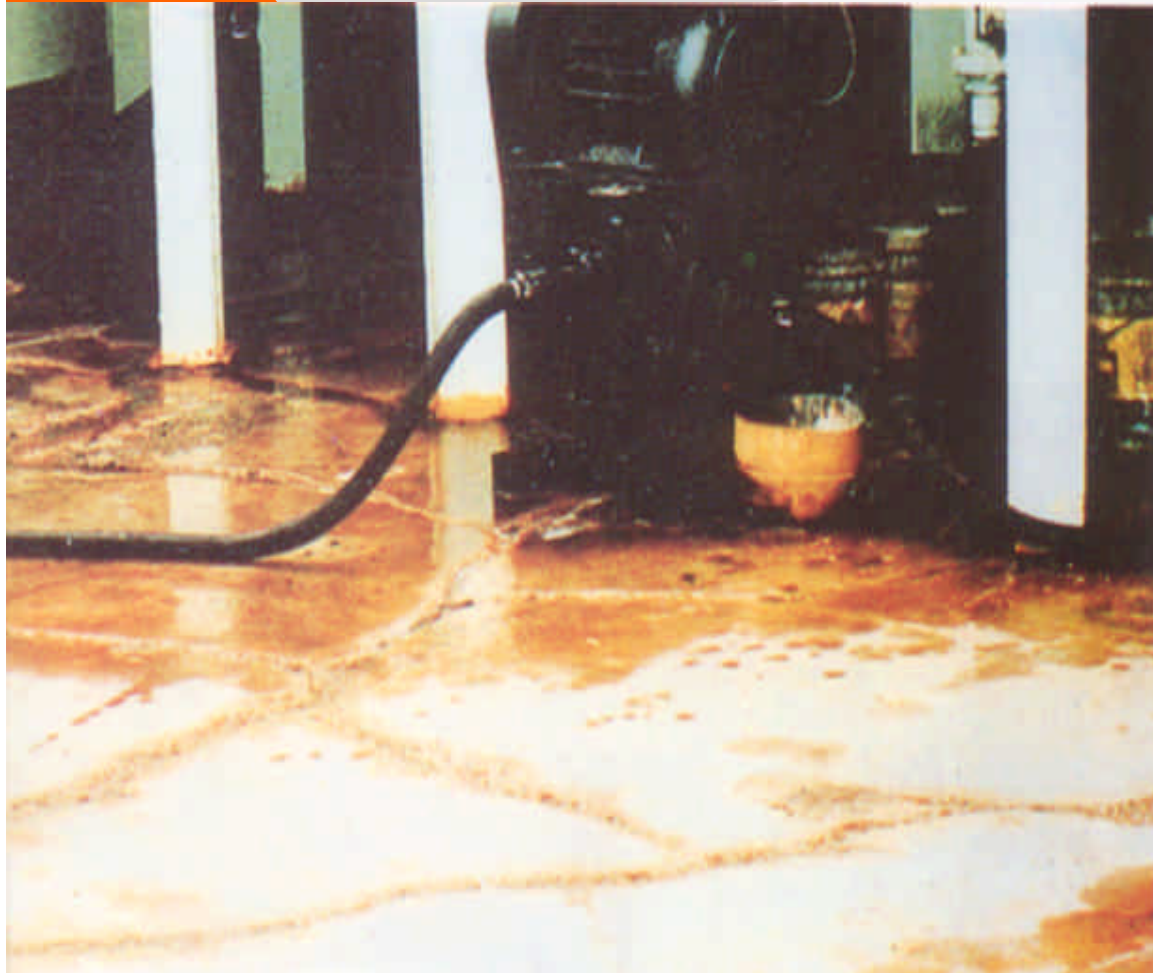
# Hardman Chemicals, NSW Australia

Hydrochloric Acid Facility 1970 - 2003

**1979: “Our Caltite floor is now 19 years old, in constant use – which compares extremely well with the life of our ordinary earliest floors”**

**2003: Harman Chemicals’ Caltite / Epoxy slab continues in service today.**

**After 31 years, the benefit of the ‘composite’ Caltite / Epoxy floor has been to deliver a more than 40 fold increase in maintenance-free, useable service life over epoxy alone**

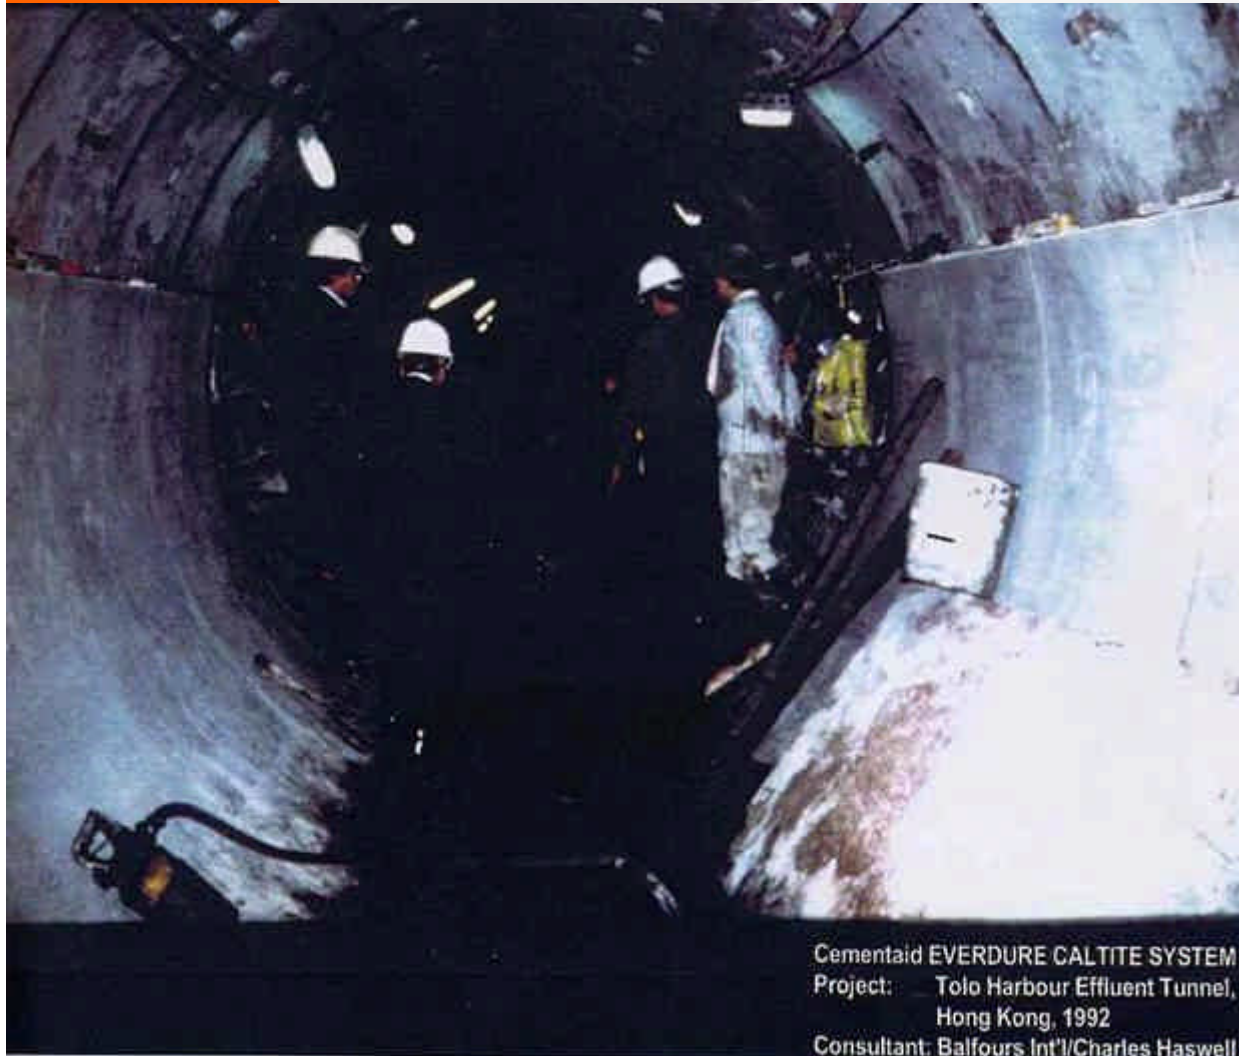
## Caltite System Concrete (Coating-free)

- Strategic Sewage Disposal Scheme Hong Kong (SSDS)
- Tolo Harbour Effluent Tunnel (1992)
- Tunnel passing over potable water mains
- Reinforced CALTITE concrete invert lining

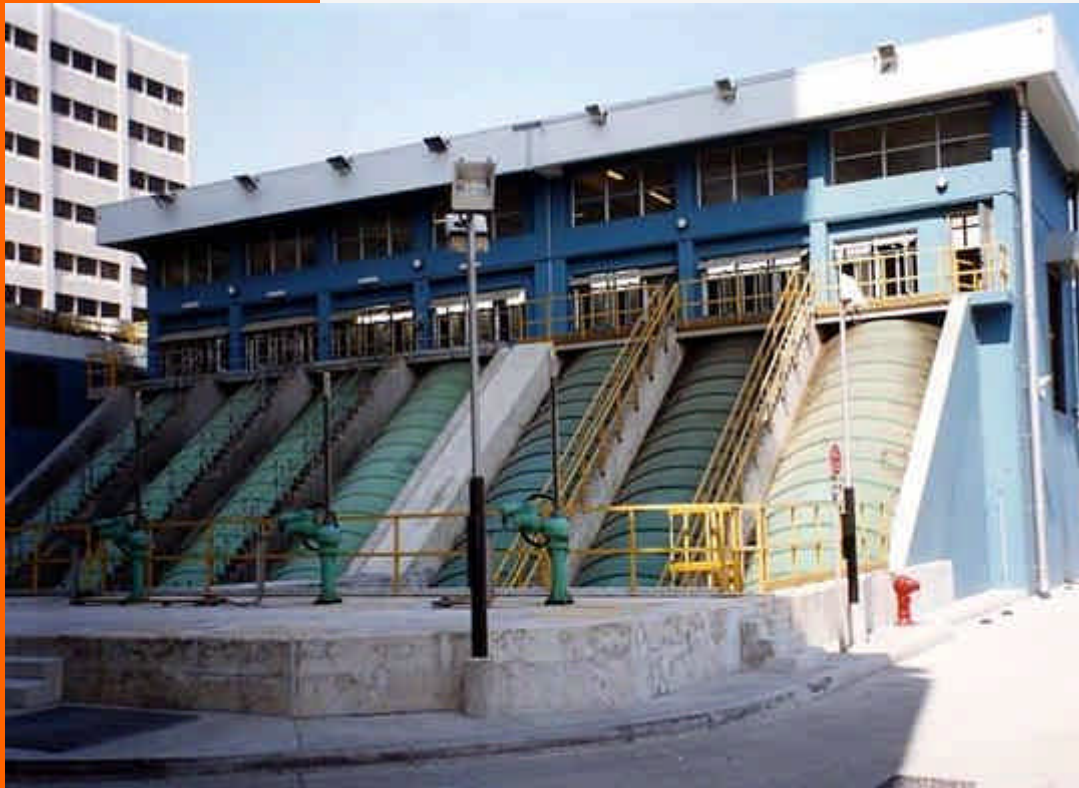
Strategic Sewage Disposal Scheme, (SSDS) Hong Kong, 1995

- Caltite System concrete
- No coatings, No membranes
- Multiple Pumping Stations handle sewage / sea-water mixture

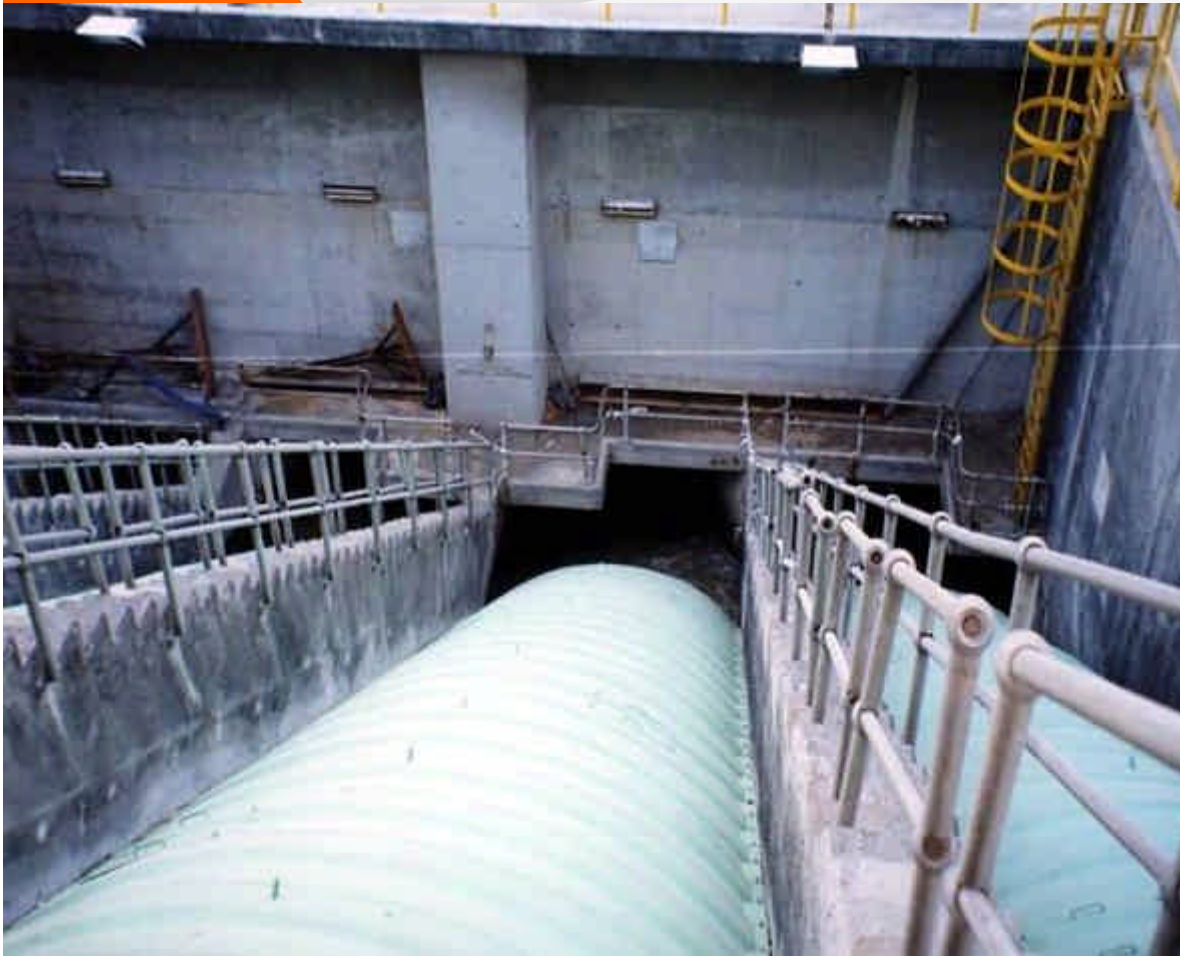
Caltite System concrete (Coating-Free)

- Strategic Sewage Disposal Scheme, (SSDS) Hong Kong, 1995
- Pumping Stations + roofs

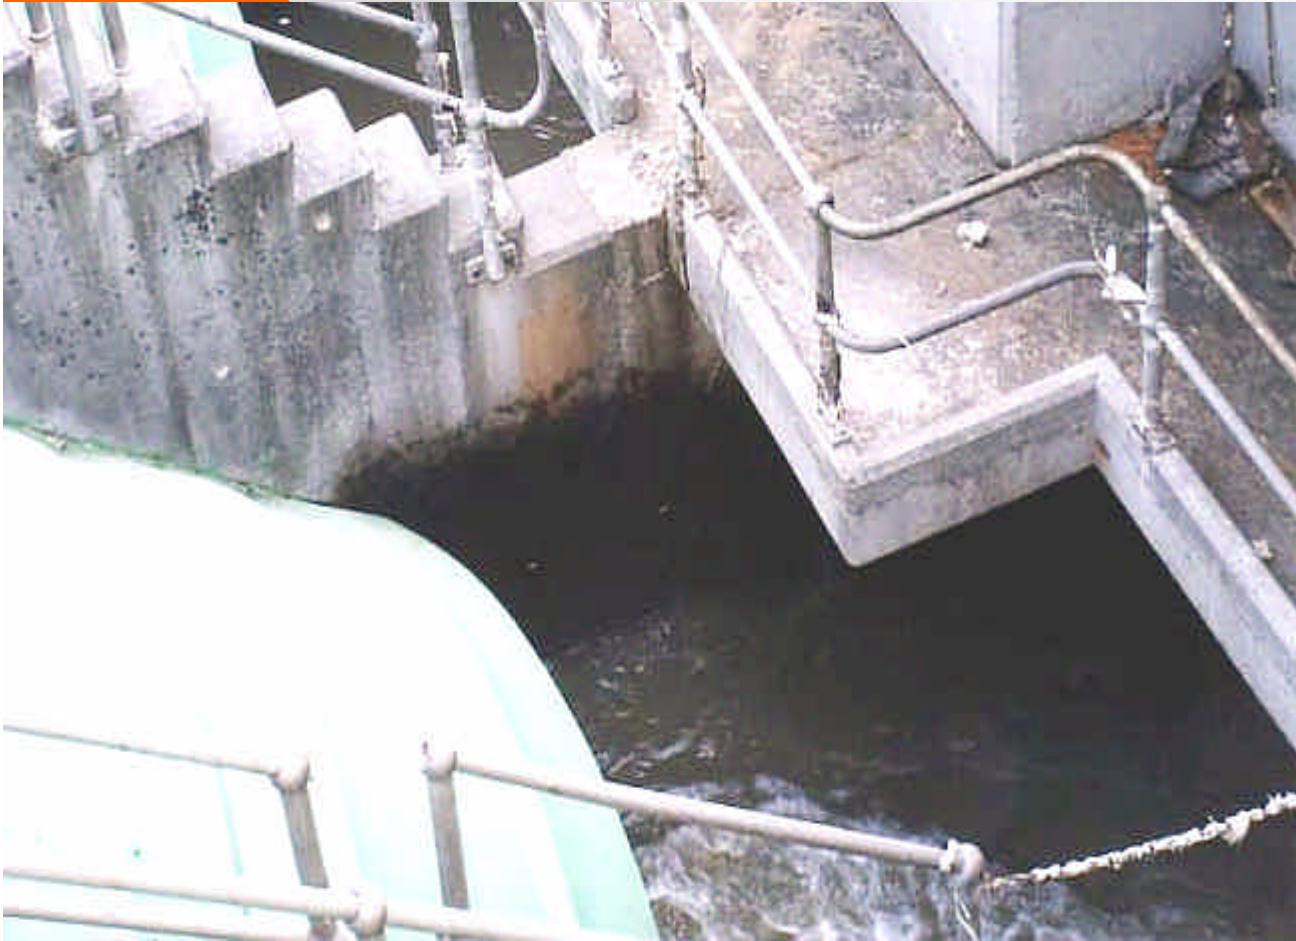
Caltite System concrete (Coating-Free)

- Strategic Sewage Disposal Scheme, (SSDS) HK 1995

- Pumping Stations + roofs

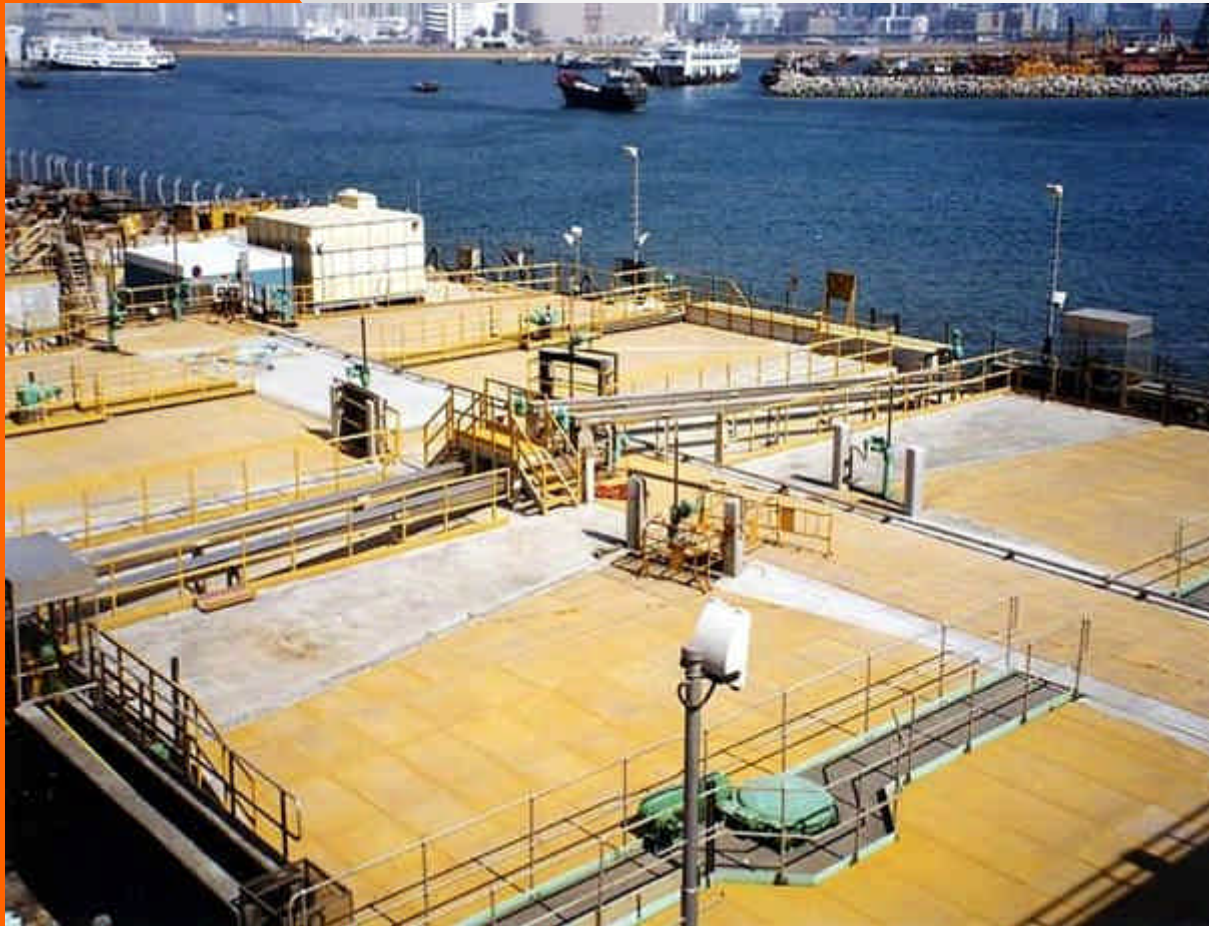
Strategic Sewage Disposal Scheme, Hong Kong (SSDS)

- Sewage / Seawater Holding Tanks
- Roof slabs over Holding Tanks
- Caltite System concrete
- Membrane - Free
- No Coatings required

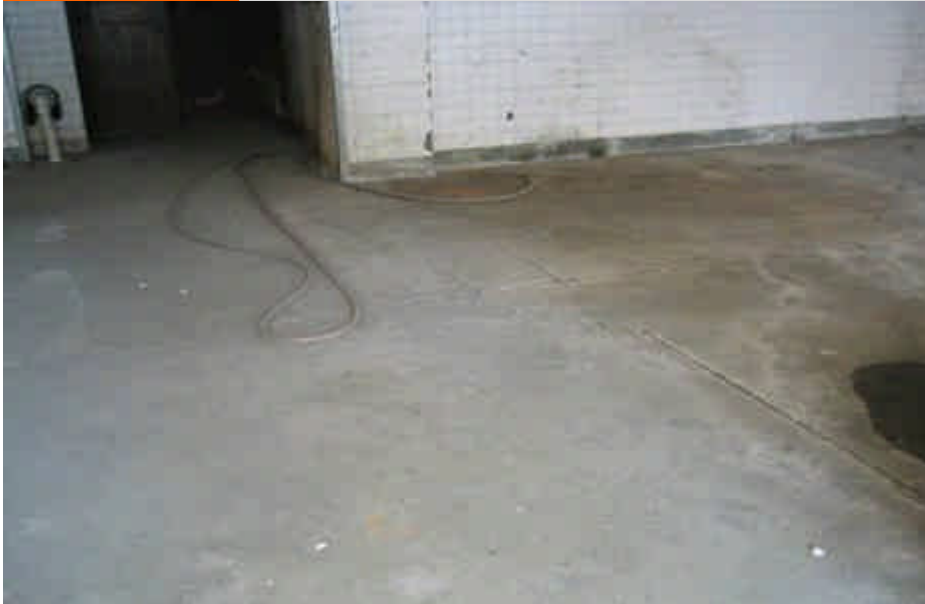
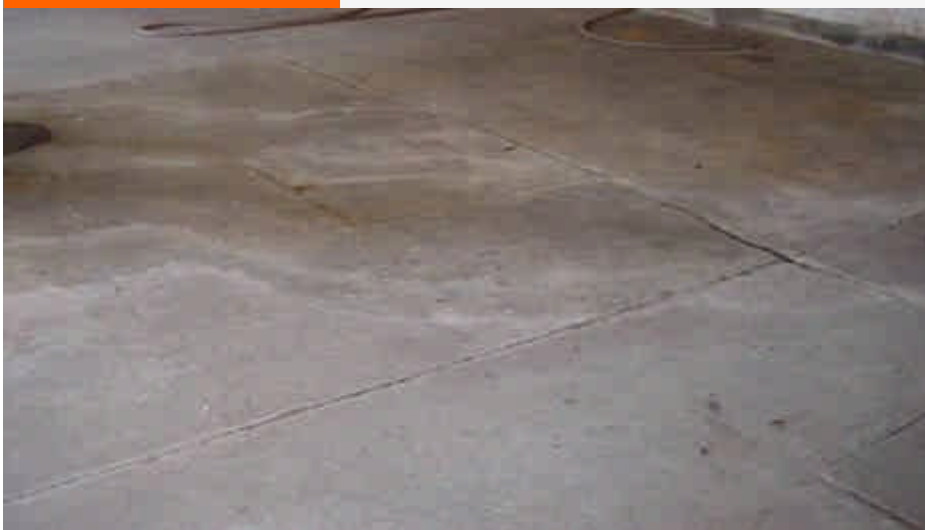
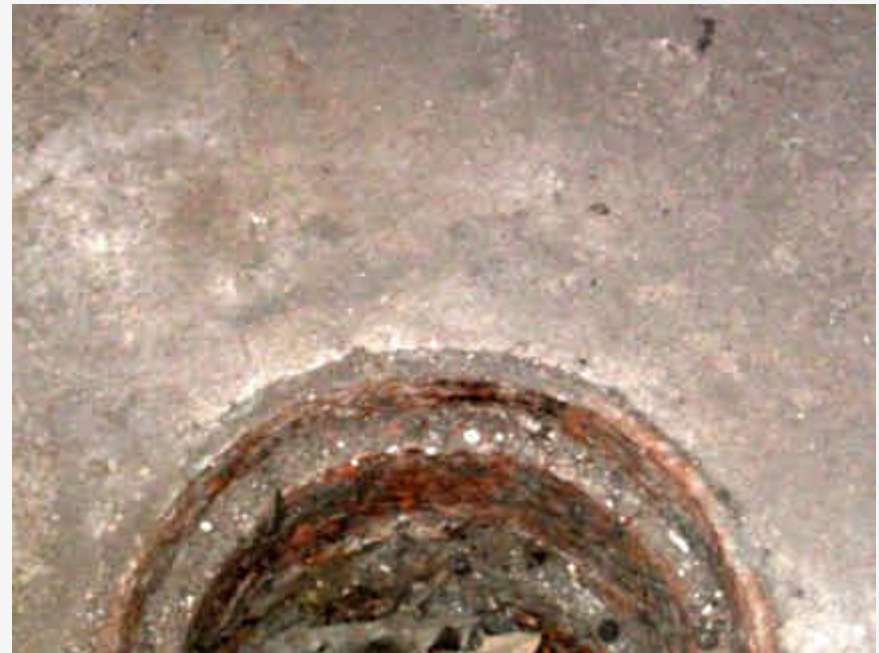
Kennedy Town Abattoir, HK - Killing Floor 1978 - 1998

- New **Cementaid Special Food Floor (SFS)** installed in 1978

**CALTITE** slab (corrosion & hygiene) +

- **STEELITE** Metallic Aggregate (impact)

- **Photo after 20 Years** ('24 / 7')

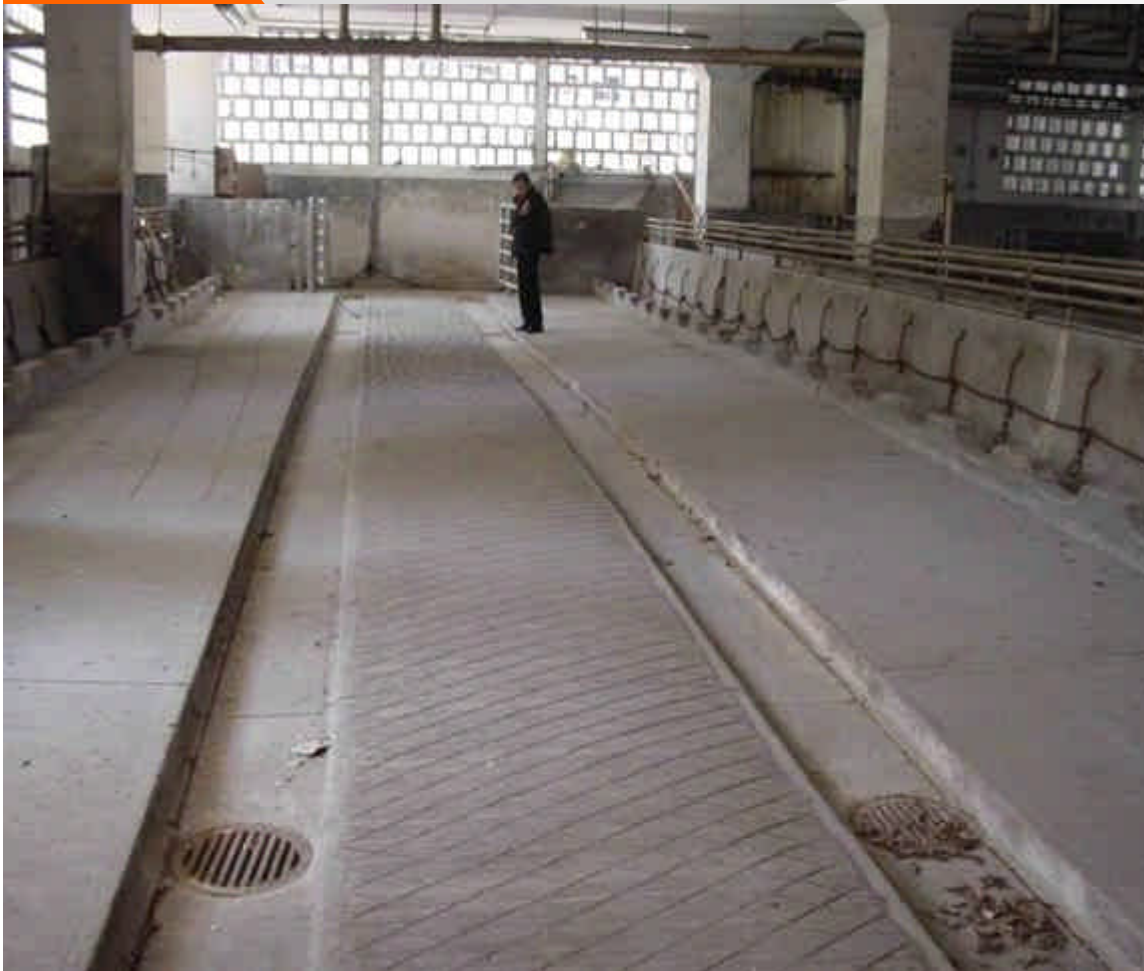
Kennedy Town Abattoir, HK - Livestock Areas 1982 – 1998

## Cementaid Special Food Floors (SFS)

- CALTITE concrete slab (corrosion & hygiene)

- Photo after 16 years
