Kalgoorlie Consolidated Gold Mines (KCGM) – Gold Ore Processing Plant, Fimiston WA

Fimiston Plant, Kalgoorlie-Boulder

Concrete Testing – Caltite and non-Caltite Concrete

284188-01 (04)

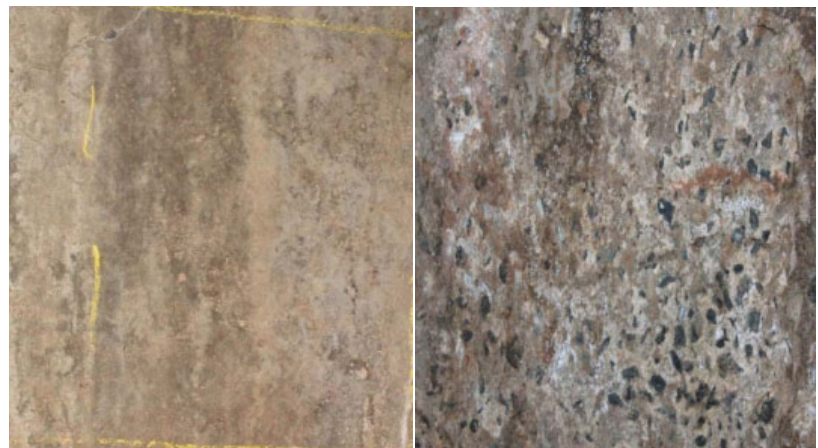
Surface Appearance

at location of core samples

WITH Caltite

WITHOUT Caltite

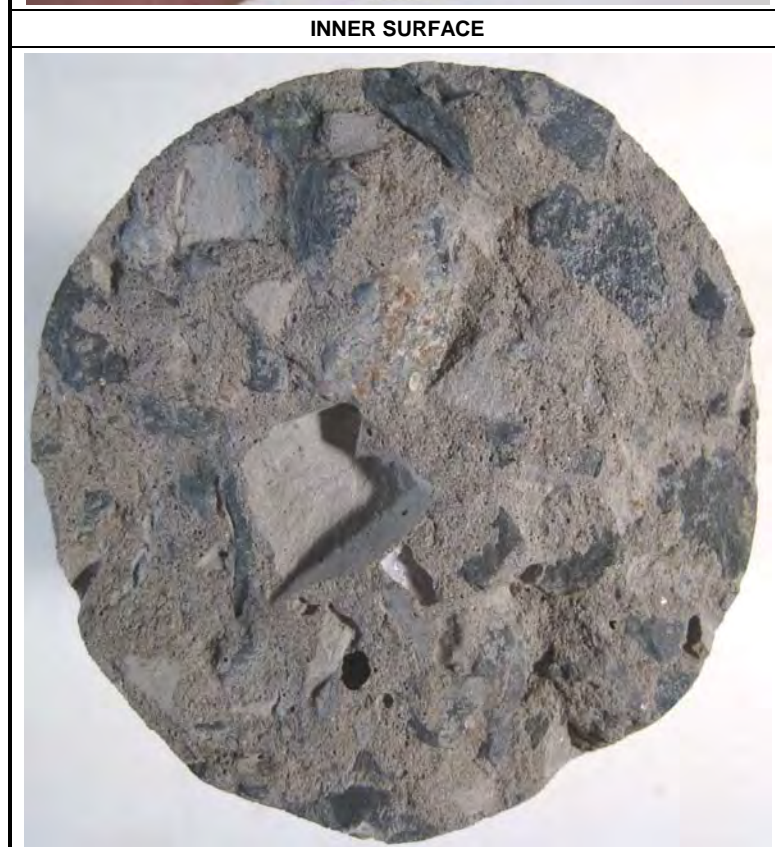
RECORD DIGITAL PHOTOGRAPH			
RSK Sample Ref.	11675/C1	Client Sample Ref.	#1
Description	View of the outer and inner surfaces of the core. Core diameter is 95mm.

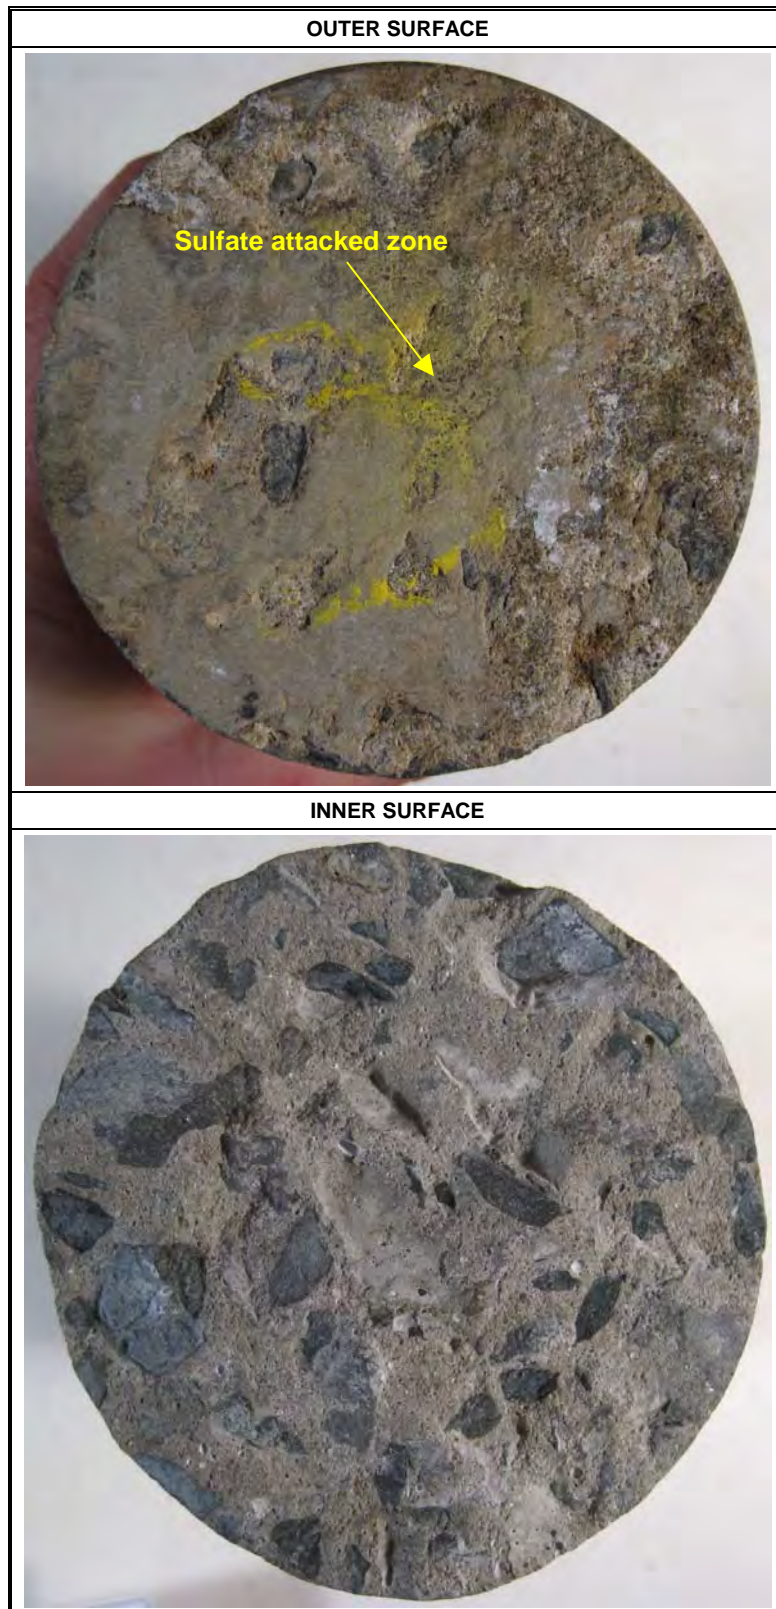
RECORD DIGITAL PHOTOGRAPH			
RSK Sample Ref.	11675/C3	Client Sample Ref.	#3
Description	View of the outer and inner surfaces of the core. Core diameter is 95mm.

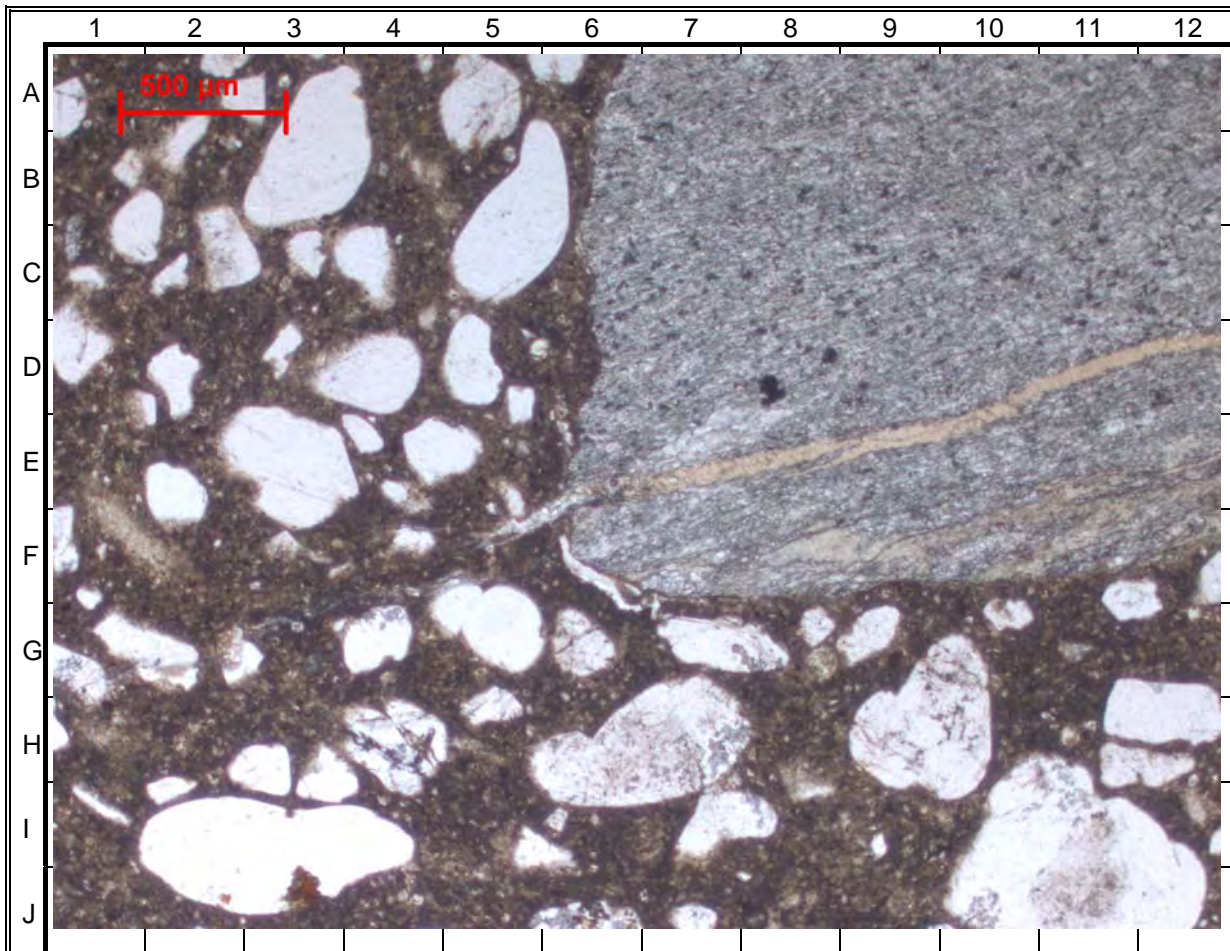
RECORD DIGITAL PHOTOMICROGRAPH			
RSK Sample Ref.	11675/C3	Client Sample Ref.	#3
Approx. Mag ⁿ	x35	Approx. Scale	10mm = 285μm
Portion Described	Concrete	Viewing Light	Plane-polarised
Description	<p>General view of the concrete, showing a microcrack (white/grey, G1 to F6) emanating from a coarse aggregate particle (D9), which was partially infilled by secondary alkali-silica gel deposits.</p> <p>A recrystallised quartz vein within a gneiss aggregate particle is shown light brown (F6 to D12).</p> <p>A closer view is shown on Sheet 14.</p>
